ARCHAEOLOGICAL CURATION-NEEDS ASSESSMENTS

An Archaeological Curation-Needs Assessment for Fort Bliss, Texas

**AN ARCHAEOLOGICAL CURATION-NEEDS ASSESSMENT
FOR
FORT BLISS, TEXAS**

**U.S. Army Corps of Engineers
St. Louis District,
Mandatory Center of Expertise for the
Curation and Management of Archaeological Collections,
Archaeological Curation-Needs Assessments
Technical Report No. 2**

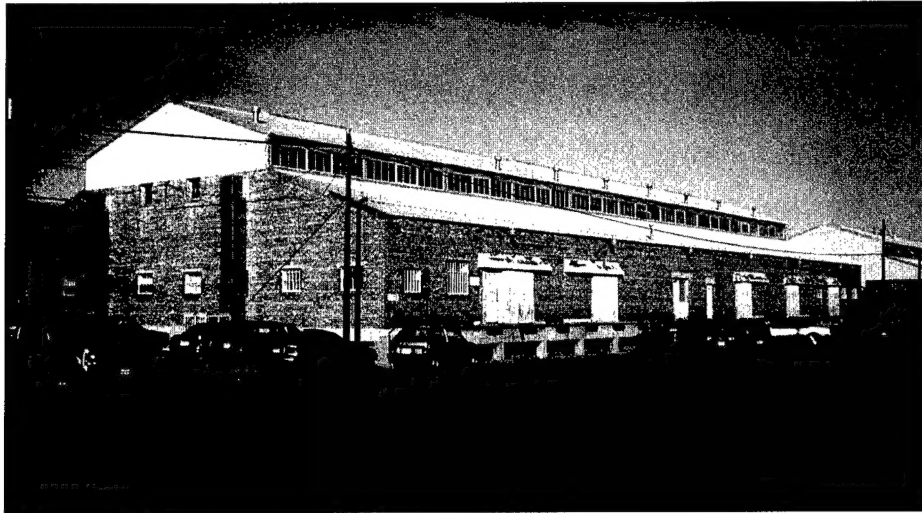
Figure 1. Exterior view of Building 1105.

This single-story building is 16,000 ft² (Figure 1). Of this, the environmental division occupies approximately 4,000 ft². The collections storage area in Building 1105 is approximately 304 ft² in size. A long-term collection storage area, laboratory, offices, library, and restrooms are included in the 4,000 ft² environmental division.

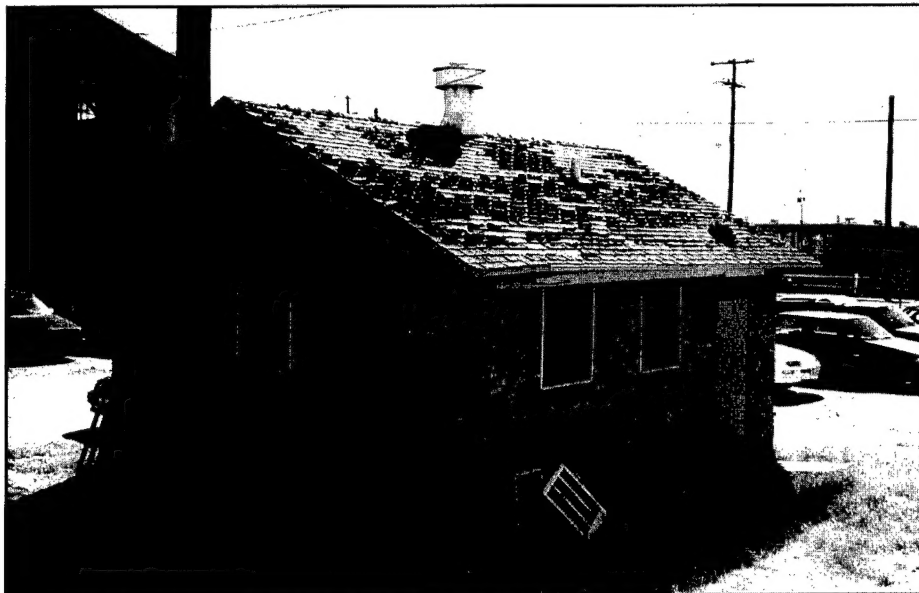
Located east across the street from Building 1105, this 144-ft², single-story building (Figure 2) serves as the repository for groundstone material. Only one-half of this building is used for archaeological storage; the other half is occupied by biological equipment and supplies.

Figure 2. Exterior view of Building 1127. Note deteriorating roof.

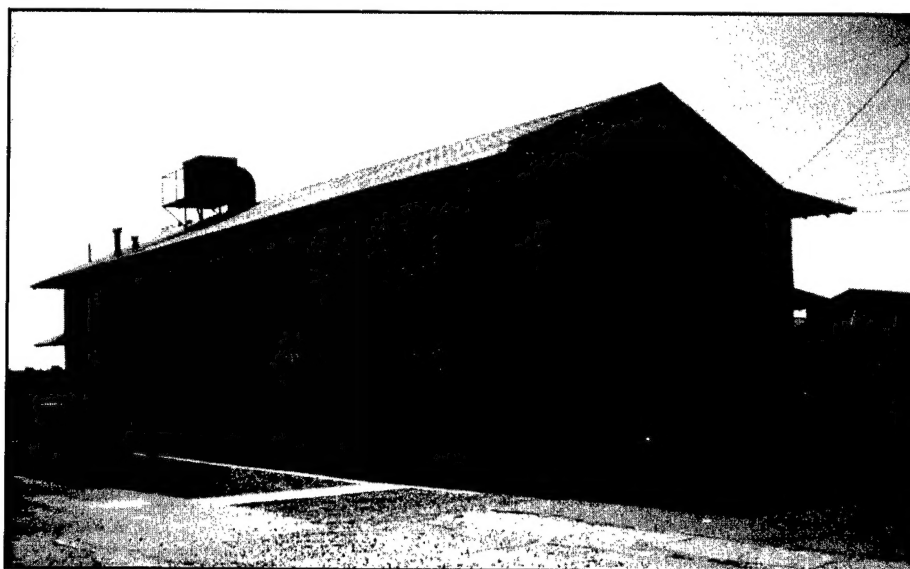
This two-story building (Figure 3), located northeast of Repositories 1 and 2, encompasses 1,110 ft². It contains various laboratories (including archaeology, geology, and soils), offices, and restrooms. An estimated 125 ft³ of material is currently undergoing analysis in this repository. Although this building is actively used, it has been condemned and poses a significant safety risk to all personnel.

Figure 3. Exterior view of Building 1160. This structure is condemned, and the load on structure floors from artifacts poses a safety hazard.

Building 1160 is a World War II-era dormitory building. Although still used as laboratory space, this building has been condemned. The roof is covered with asphalt shingles, the exterior walls are of cove lap wood siding, and the foundation has been raised onto concrete pilings. There is evidence of dry rot in the siding. Interior walls and the ceiling have been covered with sheetrock, and the floor is elevated and covered with tile. There are 37 windows in this double-story building: four face north, five face south, 13 east, and 14 west. Most are partly shaded by venetian blinds. There are numerous interior office doors, all single, wood panel. Of the five exterior doors, two are on the north side (one on the lower level, one on the upper level), and three are on the lower level (two facing east, one facing west). One of the east facing doors is a double, wood panel door; all others are single, wood panel.

This building includes artifact washing and processing areas, a temporary artifact holding area, materials/supplies storage, a mechanical/utility room, offices, and restrooms. The electrical and plumbing systems have been upgraded at some time in the past. However, both restrooms have recently been condemned due to plumbing problems and the unstable condition of the floors (Figure 9). The contracted janitorial person refused to come and maintain the restrooms, so staff temporarily repaired the women's restroom floor by stabilizing it with one by twos. Additionally, there are places on the second floor where the sheetrock has separated from the ceiling. This building is not structurally sound and should not be used for archaeological laboratory space. There is too much weight on the upper floors, and the building itself is a fire hazard. All personnel should be removed immediately.

1. As Building 1160 has been condemned, is structurally stressed from current archaeological artifact load, has no fire protection, and only has a 15-minute burn rating, it is recommended that all activities in this building immediately be moved. The safety of all personnel is currently compromised, and any supervisor who continues to let his/her staff work there is putting their safety at risk.
2. If collections are to remain in Building 1127, upgrade the fire detection/suppression system. Minimally, install smoke alarms, fire extinguishers, and sprinkler systems.
3. If the groundstone collection is to remain in Building 1127, replace the damaged shingles on the roof, and install a dead-bolt lock on the door.
4. Install an electronic motion detector in the collections storage area of Building 1105 as an additional security precaution.

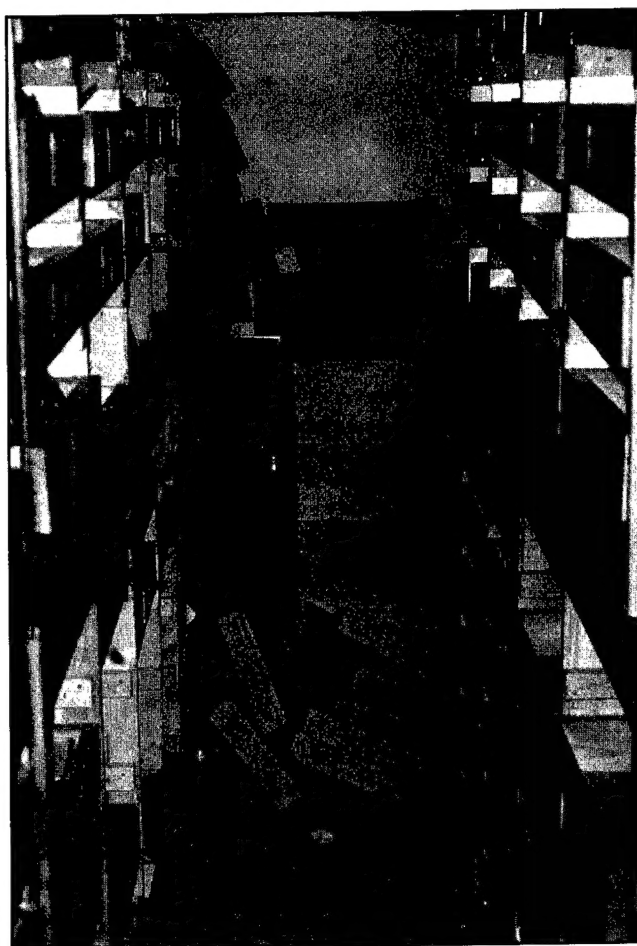
The plumbing and electrical systems have been upgraded at some point in the past. The collections storage area is filled to approximately 50% capacity, and it is estimated that it will be over 100% capacity after the reprocessing of the current collections is finished. The aisles of the collections storage room are cluttered with empty cardboard flats, empty wood drawers, and supplies (Figures 5 and 6).

Figure 5. Cluttered aisles of collections storage room in Building 1105. Access to the collections is impeded by clutter, and the fire hazard is substantial.

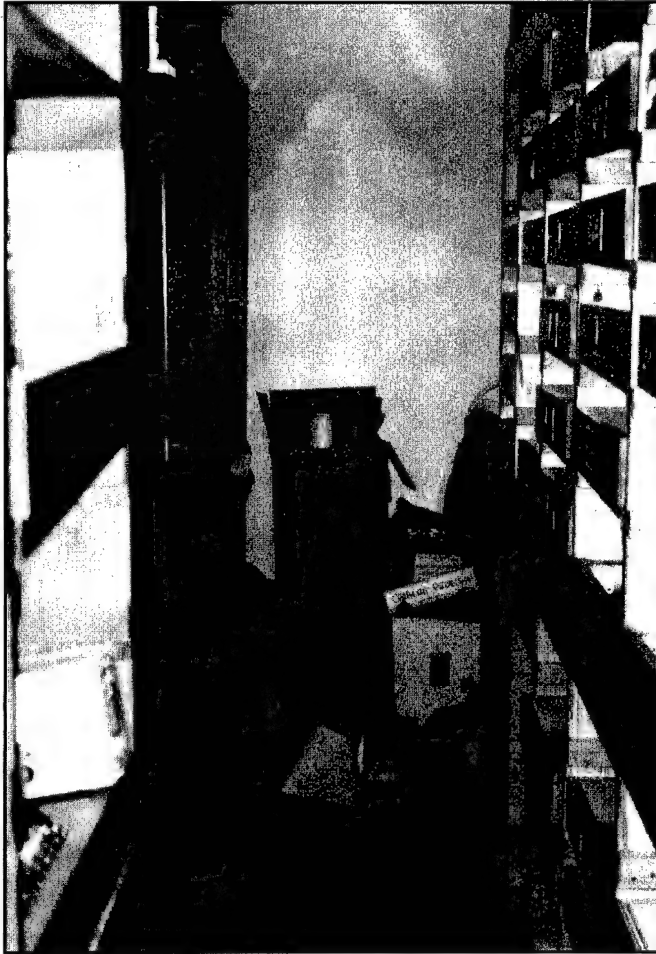
Figure 6. Cluttered aisles of collections storage room, Building 1105, pose major fire hazards.

Three fire extinguishers, all located in the laboratory adjacent to the collections storage area, and a sprinkler system constitute the fire suppression system in this building. It was impossible to tell when the fire extinguishers had last been charged as they had no tags. The aisles of the collections storage area are cluttered with empty drawers, cardboard flats, and supplies, all comprising a fire hazard.

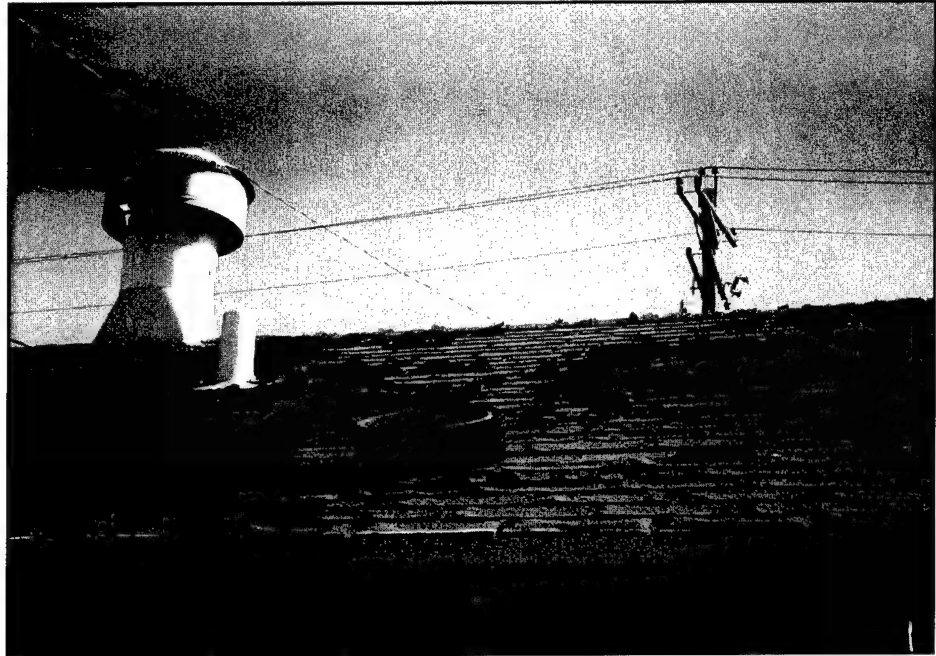
This single-story World War II-era building was originally used as a pump house. The roof is covered with asphalt shingles, many of which need replacing (Figure 7). The ceiling is constructed of wood two by fours. The foundation is poured concrete, and both the exterior and the interior walls are faced with brick. There are seven windows in this facility, all measuring 41.5 in long and 36 in wide. There is one window on the north wall, two on the south wall, two on the east wall, and two on the west wall. Windows have wood frames and are covered with metal mesh on the outside. There is one single, wood panel door on the west side of the building.

Figure 7. Damaged shingles on roof of Building 1127.

1. The shingles on Building 1127 are severely damaged.
2. Buildings 1127 and 1160 have no fire detection/suppression systems.
3. All but three of the drawers (secondary containers) in Building 1105 are overpacked and difficult to access.
4. Only Buildings 1105 and 1160 have any type of temperature controls, but none of the facilities have any way to monitor or control humidity.
5. There is no integrated pest management system in place for any of the facilities. Certain types of insects are known to damage paper records beyond repair, destroying important information. Additionally, rodents and snakes are known to nest in packing material, eventually disturbing and possibly destroying artifacts.
6. The computer records are the only type of documentation that have a security back-up copy; however, the copies are not catalogued.

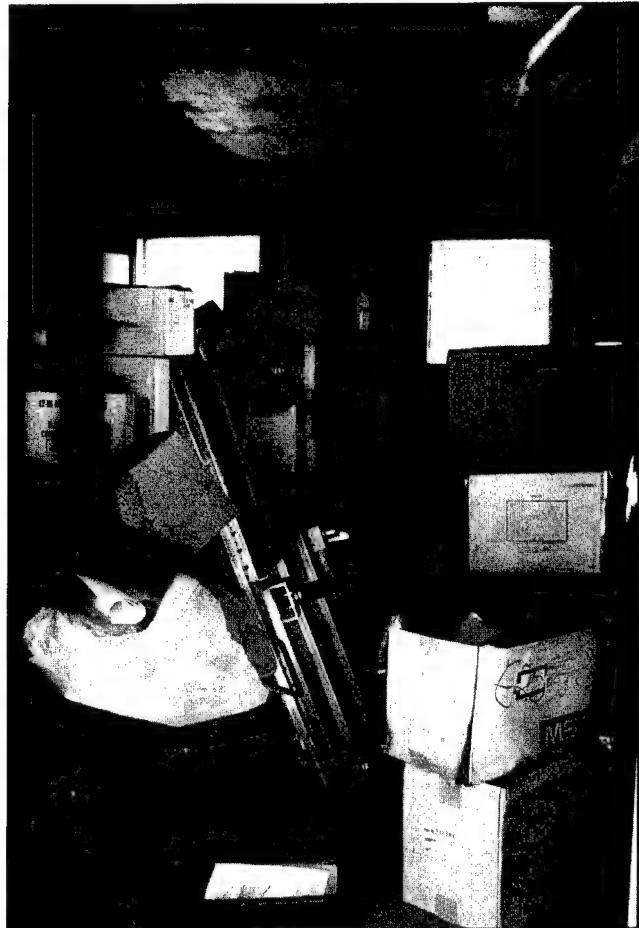
Only one-half of the 144 ft² is devoted to the storage of archaeological collections; the remaining half is dedicated to the haphazard storage of supplies and equipment used by the biologists. The groundstone storage area is currently filled to approximately 30% capacity (Figure 8); however, because of the technique of storing groundstone items in wood drawers, as well as the weight of the material, it is doubtful that much more archaeological material will satisfactorily fit into this storage facility.

Figure 8. Clutter in groundstone storage, Building 1127, poses a major fire hazard. Note sagging storage support in ceiling.

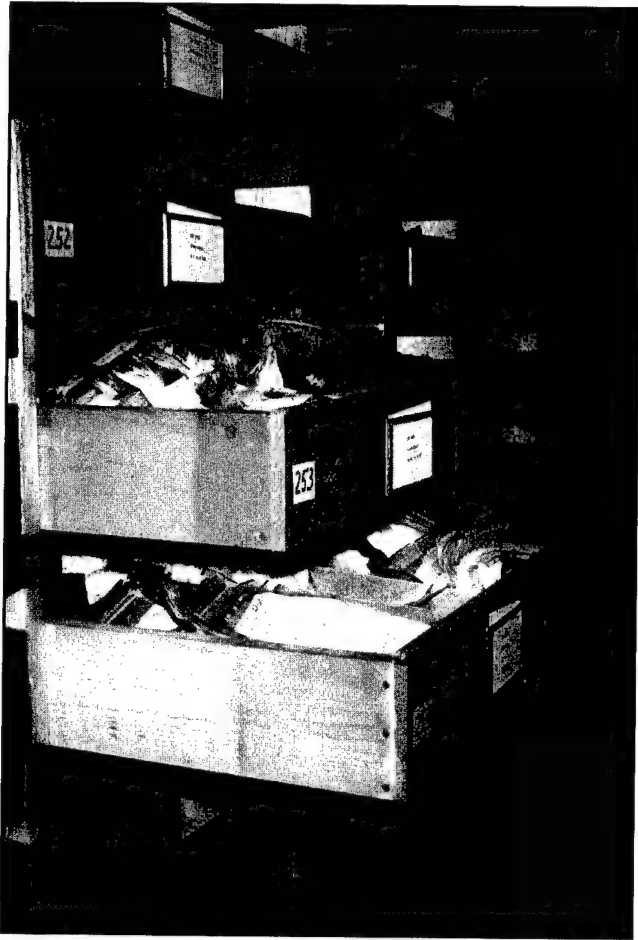
All of the artifacts in Building 1105 are curated in 0.75 ft³ unsealed, unlined wood drawers constructed of nails and glue. Drawers contain acidic paper labels with typed information pertaining to Fort Bliss site numbers and a series of artifact catalog numbers. Many of the primary containers include dividers constructed of acidic cardboard beer flats. All but three of these drawers are overpacked and difficult to access (Figure 10).

Figure 10. View of storage units and primary and secondary containers in Building 1105. Artifacts are improperly stored and overpacking of drawers tears artifact bags and hinders access to the collections.

5. All but three drawers in Building 1105 are over-packed. It is not only difficult to tell which sites are filed in these drawers, but also awkward to remove and replace secondary containers within the drawers. Repack all drawers and collections so that they are easier to manage and collections are easier to access. In their present condition the collections cannot be used or properly managed.

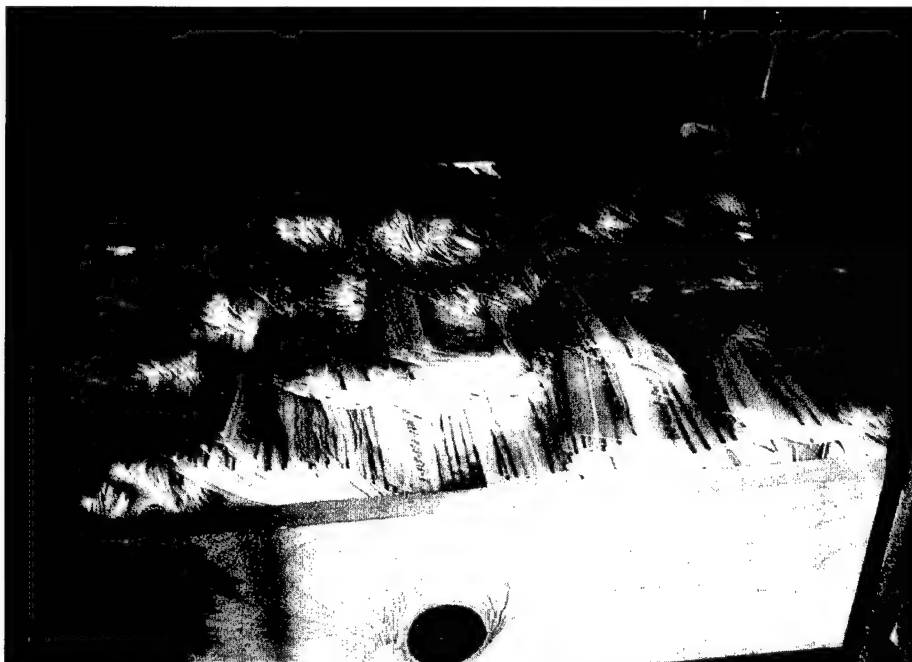
Secondary containers in Building 1127 consist of zip-lock plastic bags (Figure 12) and artifacts stored loose in the drawers. Because of their large size, most of the groundstone artifacts are stored loose in the drawers (Figure 13) or on the floor (Figure 14).

Figure 12. Example of overpacked drawer, which hinders efficient access to the collections.
